INSPECTION REPORT

For the Property at:
660 SHAWNEE WOODS ROAD
MEDINA, MN 55340

Prepared for: JOHN DOE
Inspection Date: Monday, November 25, 2019
Prepared by: Dustin Cortez

RE: Report No. 1134, v.3
660 Shawnee Woods Road
Medina, MN
55340

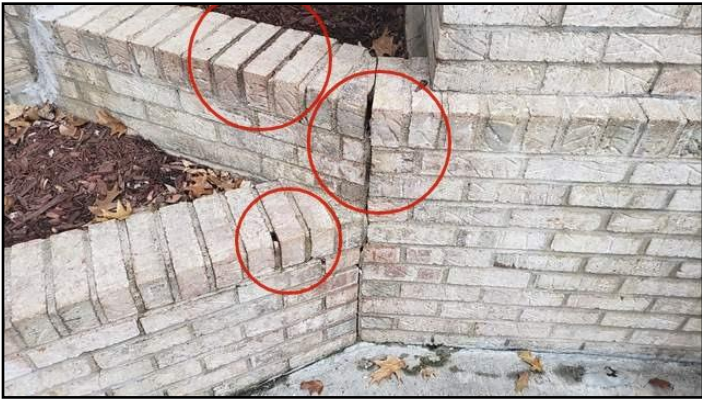
Condition: • [Mortar deterioration](#)

A few small sections of mortar are deteriorating at the brick siding at the front of the home.

Deteriorated Mortar

*Recommend filling the gaps with more mortar to prevent further damage to the mortar and masonry.

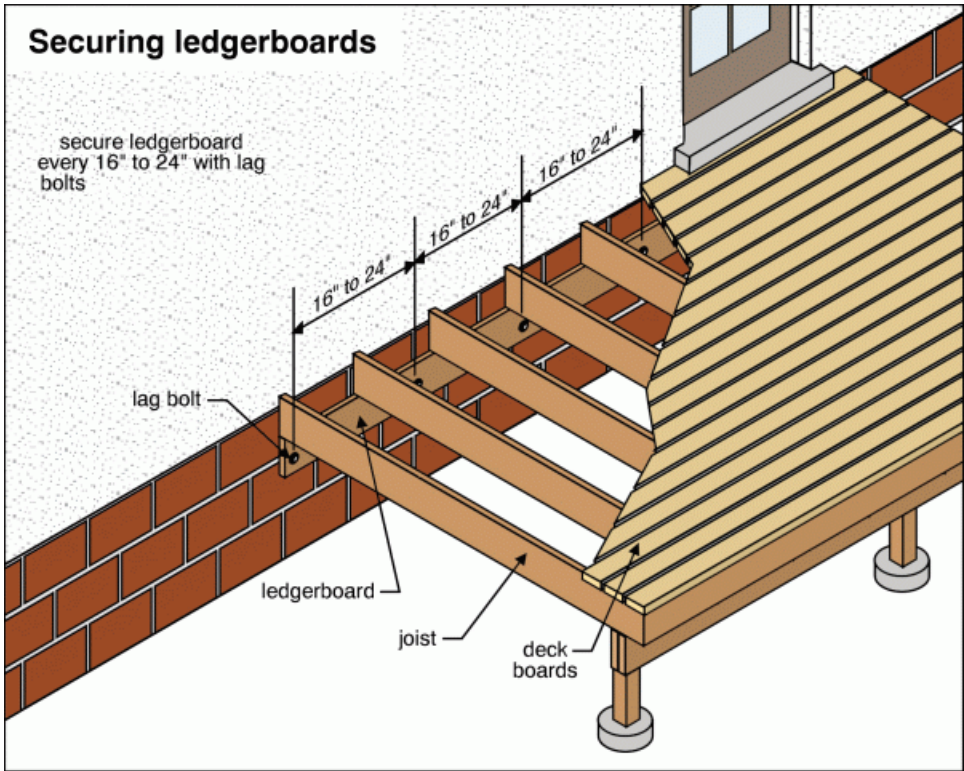
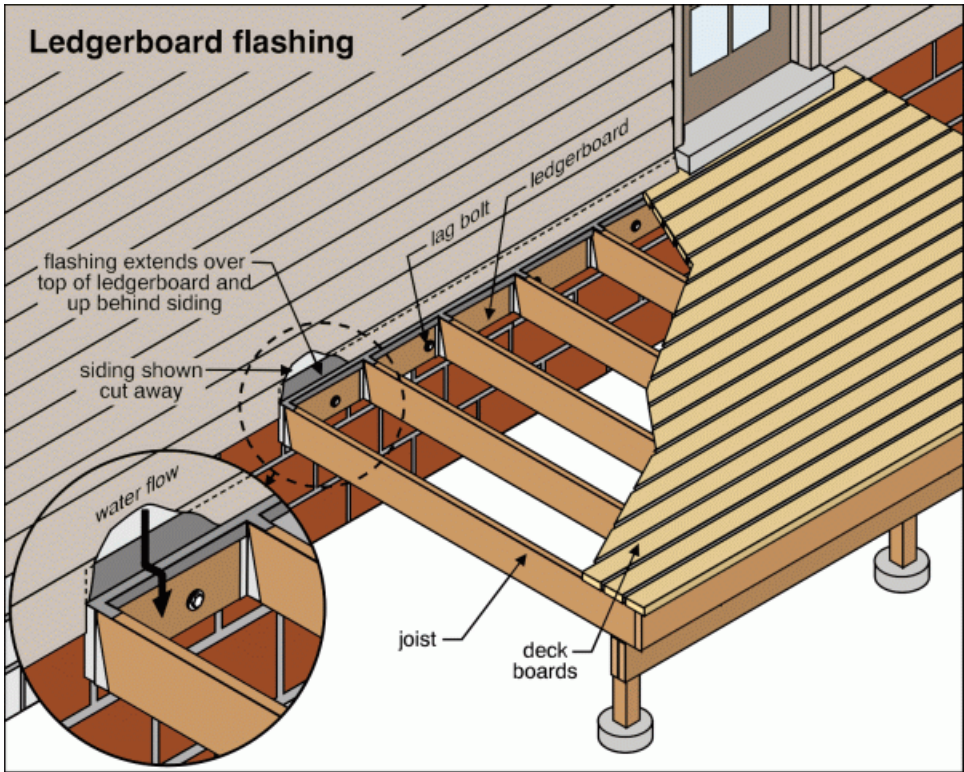
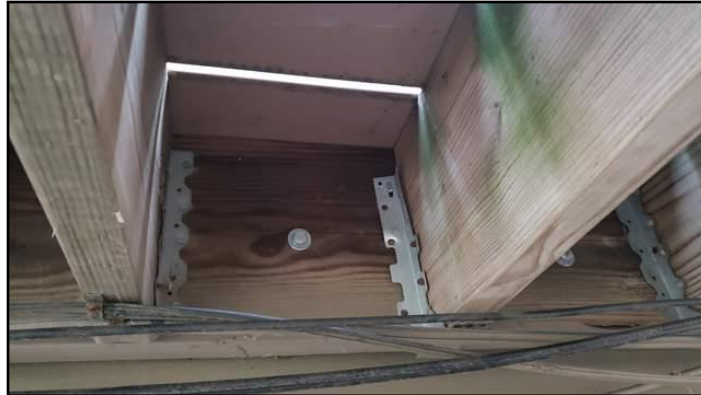
Condition: • [Missing flashing at deck connection](#)

Missing Flashing @ Ledgerboard

*Recommend monitoring the sealant for further deterioration and repair sealant as necessary.

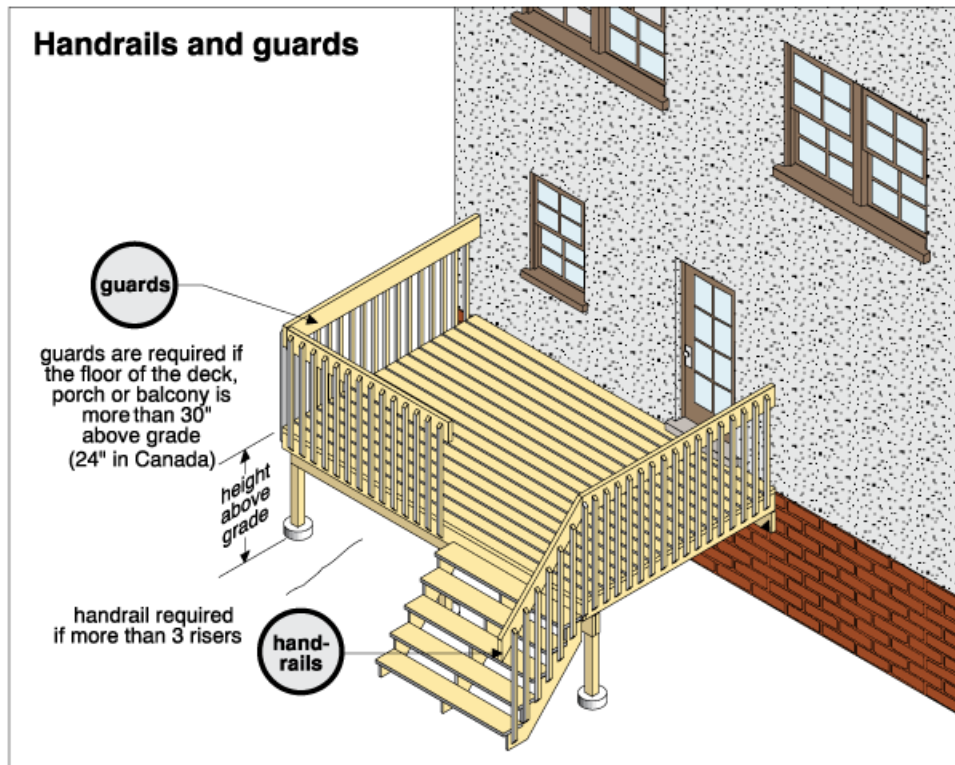
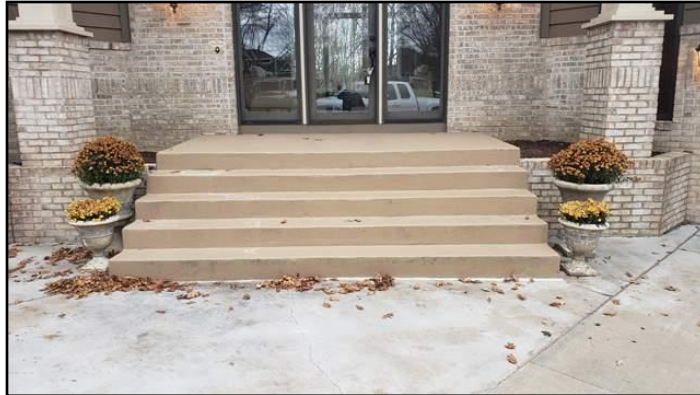
Condition: • [Missing](#)

Implication(s): Fall hazard

Missing Handrail

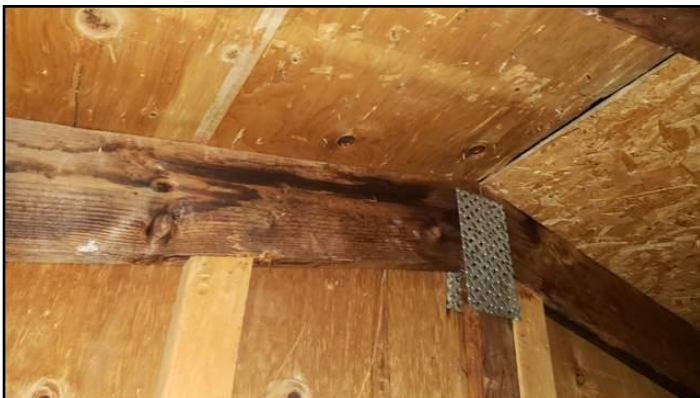
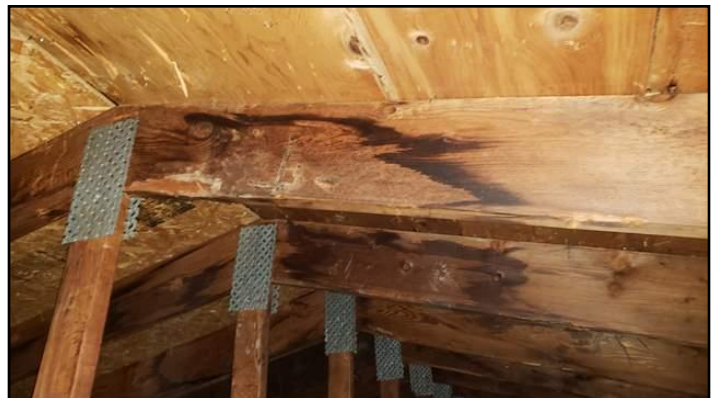
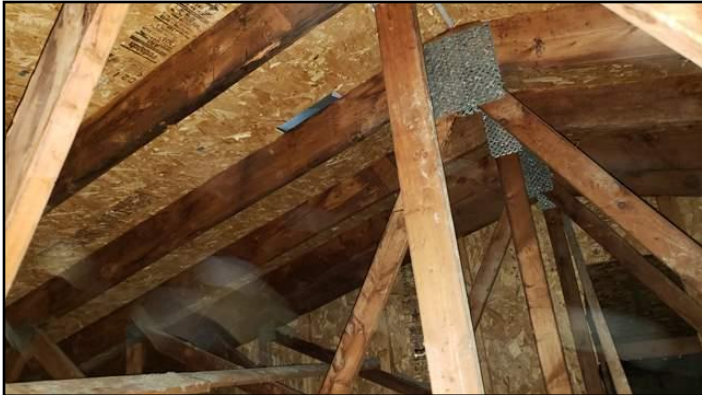
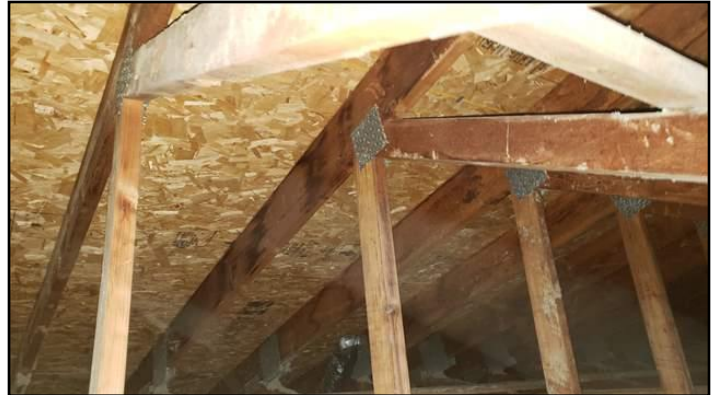
Condition: • Signs of moisture were noted on the trusses in the attic and garage rafters. The areas were not wet at the time of the inspection.

Sign Of Moisture

*Recommend requesting disclosure as to whether there has been moisture or other issues in these areas, what was done to mitigate the issue & has the remedy been successful? Also recommend monitoring these areas for any further signs of damage & taking appropriate action if necessary.

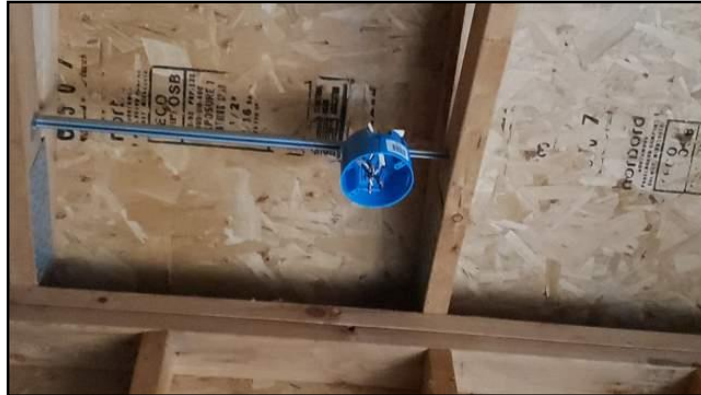
Condition: • [Cover loose or missing](#)

1 Junction box is missing a cover at the ceiling in the detached garage.

Missing Cover Plate

*Provide a cover to protect the wiring from moisture.

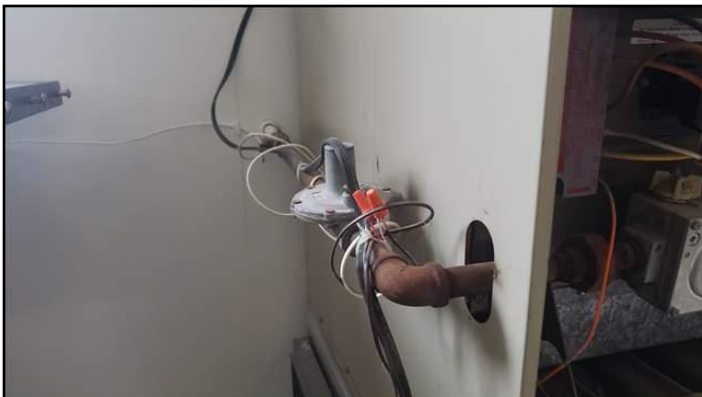
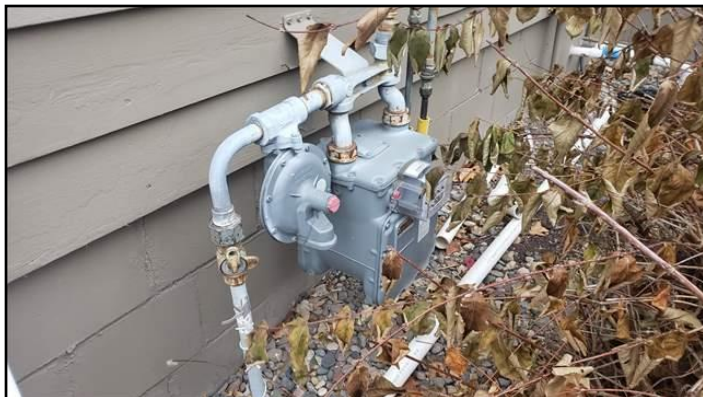
Small hints of gas could be smelled around the meter located at the back of the house and around the regulator in the garage.

Condition: • [Leak](#)

Potential Leak @ Gas Line

*Recommend having the gas company investigate and provide estimates and recommendations for repairs.

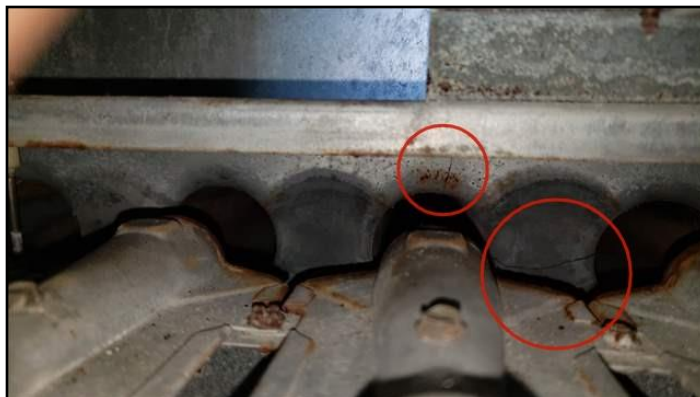
Condition: • A couple of cracks were noted at the combustion chamber for the house furnace. This can happen with a furnace this age. Heat causes the metal to expand. When the furnace shuts off, the metal cools down, allowing the metal to contract. This constant expansion and contraction of the metal over the years causes it to fatigue and sometimes crack. The danger is it can cause toxic gasses to get released into the home.

Cracked Burners

*Recommend having the furnace serviced by an HVAC specialist to provide estimates and recommendations for repairs.

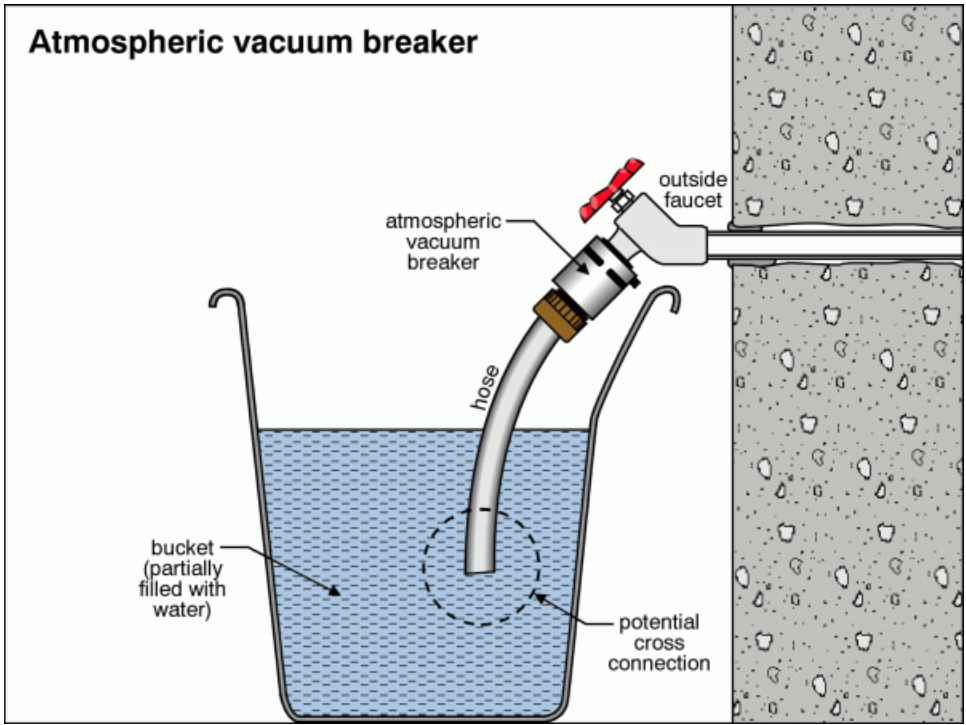
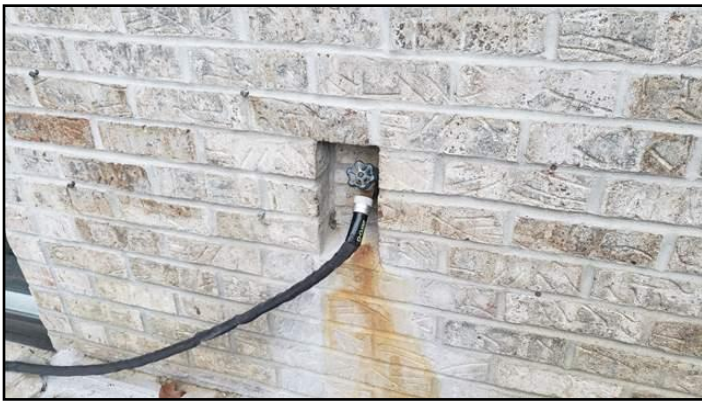
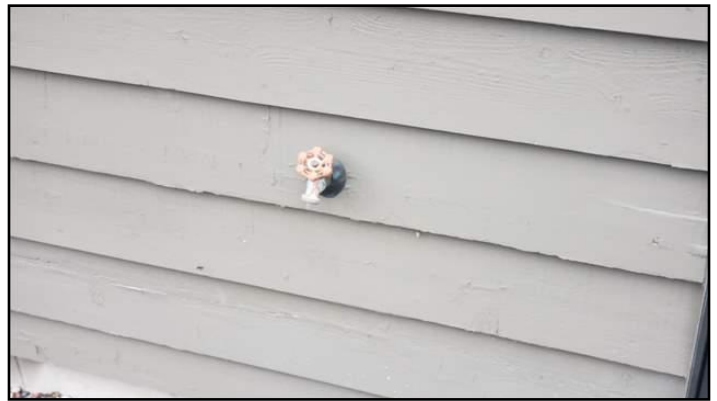
Condition: • [Backflow prevention missing](#)

Missing backflow prevention on both outside spigots.

Missing Backflow Prevention

*Recommend installing backflow prevention on both spigots to prevent water that is left in the hose line from backing up into your drinkable water.

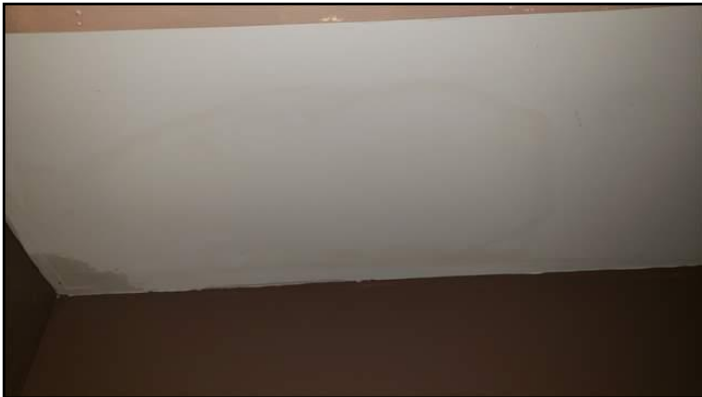
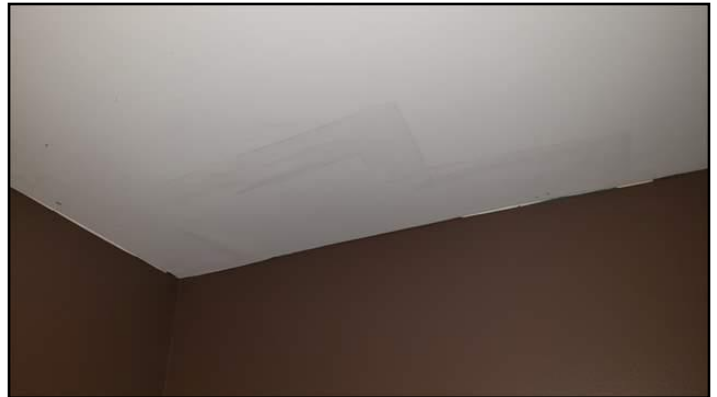
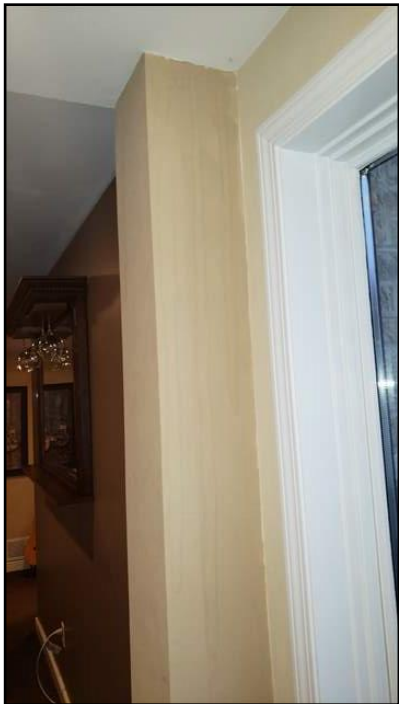
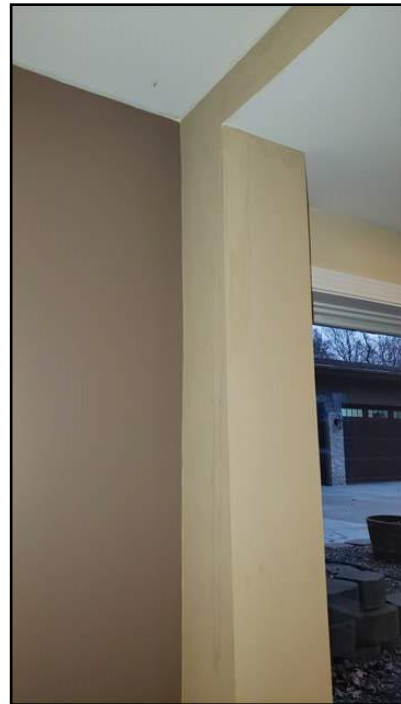
Condition: • Water stains

Water stains were noted on the ceiling and walls in the rec room and the adjacent bedroom. These stains are most likely from the bathroom waste plumbing directly above these areas. No leaks could be seen during the inspection however, some of the bathroom plumbing could not be inspected due to there being no access.

Sign Of Moisture

*Recommend requesting disclosure as to whether there has been moisture or other issues in this area, what was done to mitigate the issue & has the remedy been successful? Also recommend monitoring this area for any further signs of damage & taking appropriate action if necessary. Lastly, repair/replace/correct any areas of the ceiling/walls necessary for aesthetics purposes.

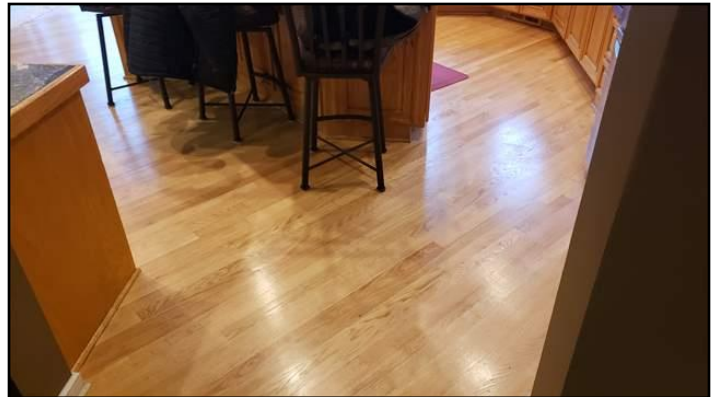
Condition: • [Squeaks](#)

The floors in the hall and kitchen squeak a little bit. After time the floor joist will bend slightly causing the nails to separate from the joist which causes them to move (squeak).

Squeaky Floors

*Recommend repairing the floor joists whenever the flooring is replaced.

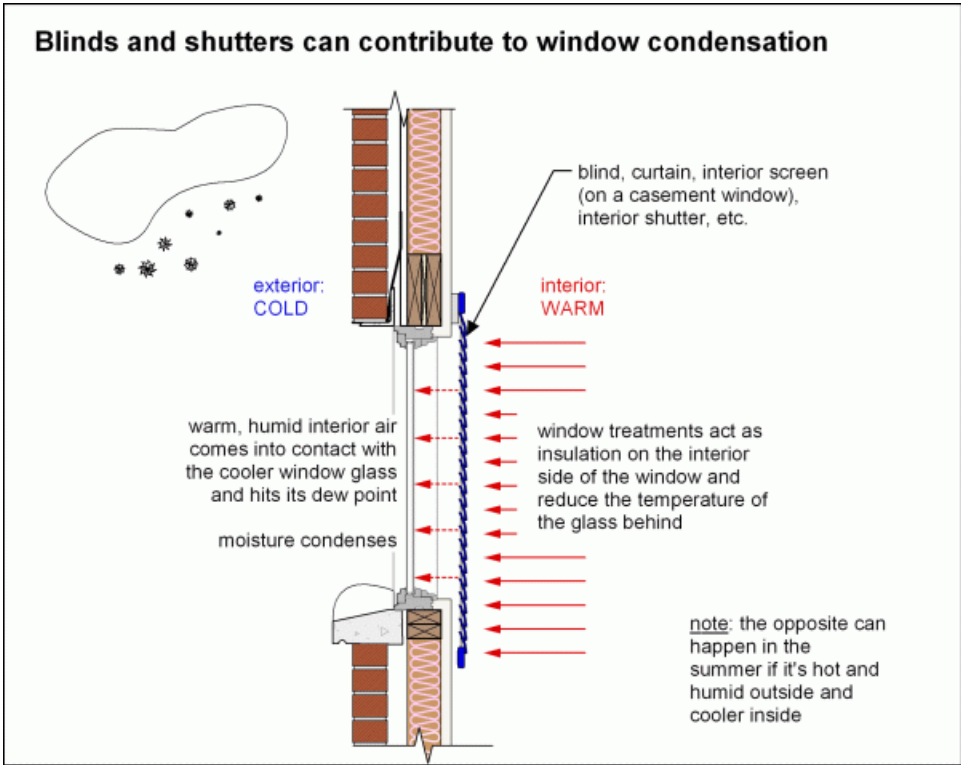
Condition: • [Excess condensation](#)

Excess condensation was noted at one of the rec room windows. This is a sign of worn or lost seals. Ultimately the only way to mitigate this issue is to replace the seals and window pane.

Excess Condensation

*Recommend replacing the seals and window panes for the best results.

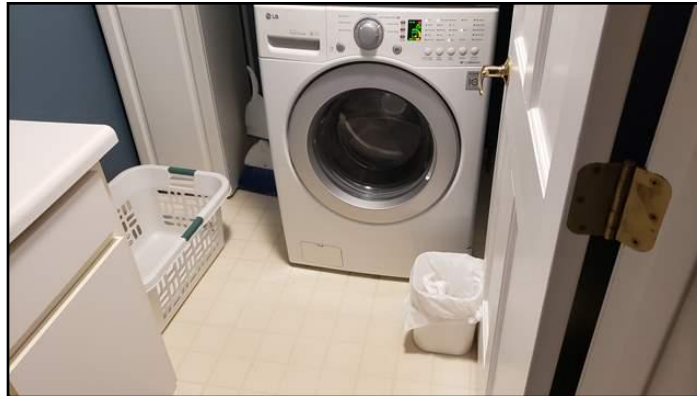
Condition: • Drip pan missing

There is currently no drip pan underneath the washer on the top floor. Recommend installing a drip pan to protect the floor/sub floor from any potential leaks.

Missing Drip Pan
