INSPECTION REPORT

For the Property at:
660 SHAWNEE WOODS ROAD
MEDINA, MN 55340

Prepared for: JOHN DOE
Inspection Date: Monday, November 25, 2019
Prepared by: Dustin Cortez

RE: Report No. 1134, v.3
660 Shawnee Woods Road
Medina, MN
55340

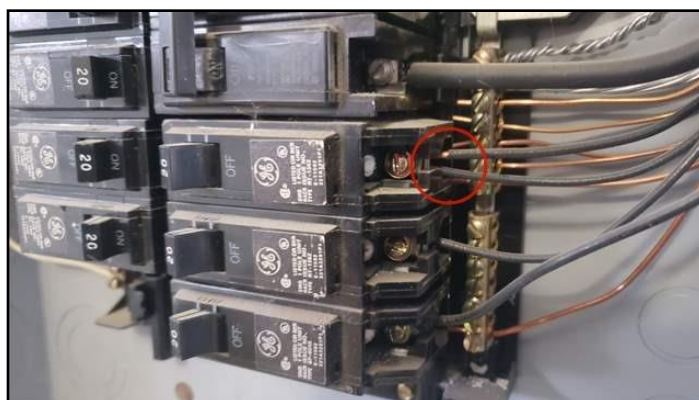
Condition: • The third breaker from the bottom on the right side is double tapped and is not suitable for such action. Each breaker is designed to handle a certain electrical load. If the circuit is double-tapped or, double lugged, (having more than one wire attached to it), then it will not be able to handle the load when it is required. This could be responsible for wires pulling away from the screw (lug), cause overheating, and in some instances, fires.

Double Tapped Breaker

*Recommend removing one of the wires and installing it in its own breaker for optimum performance.

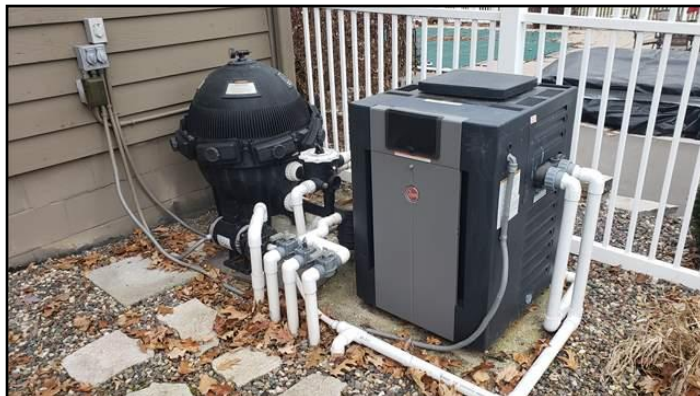
Pool Equipment Not Inspected

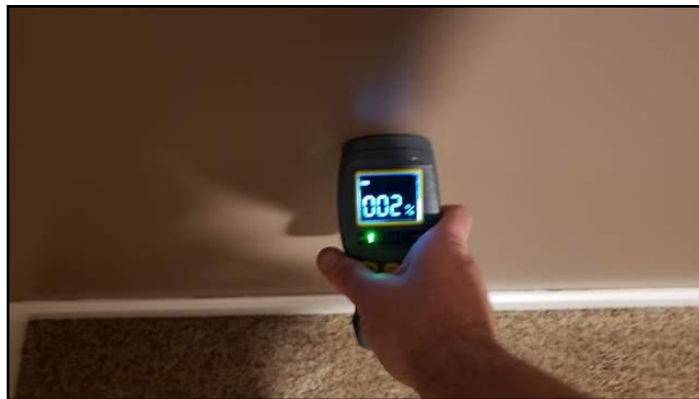
Moisture Levels 30% and lower are considered to be normal levels.

Wall Moisture Test Performed
