INSPECTION REPORT

For the Property at:
660 SHAWNEE WOODS ROAD
MEDINA, MN 55340

Prepared for: JOHN DOE
Inspection Date: Monday, November 25, 2019
Prepared by: Dustin Cortez

RE: Report No. 1134, v.3
660 Shawnee Woods Road
Medina, MN
55340

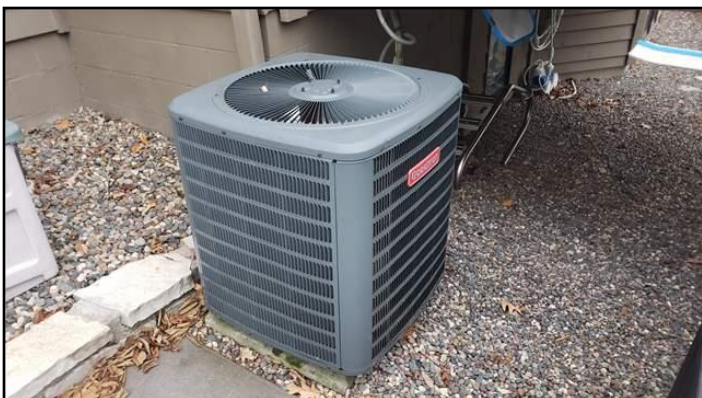
Compressor Inspected

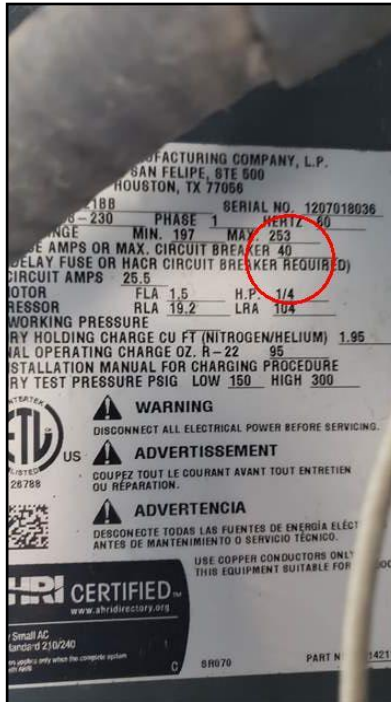
Data Plate Noted For Max Amps

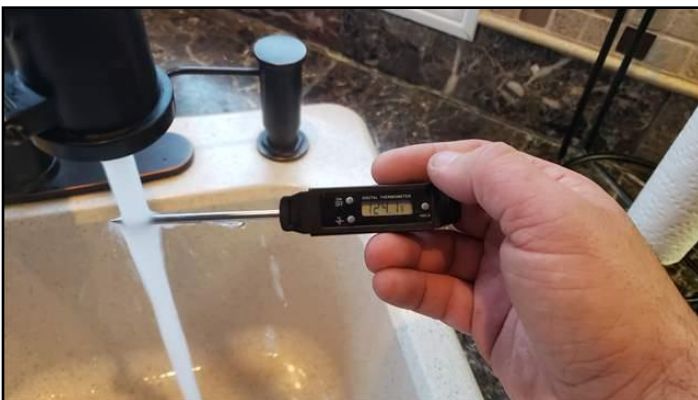
Hot Water Tested 124 Degrees

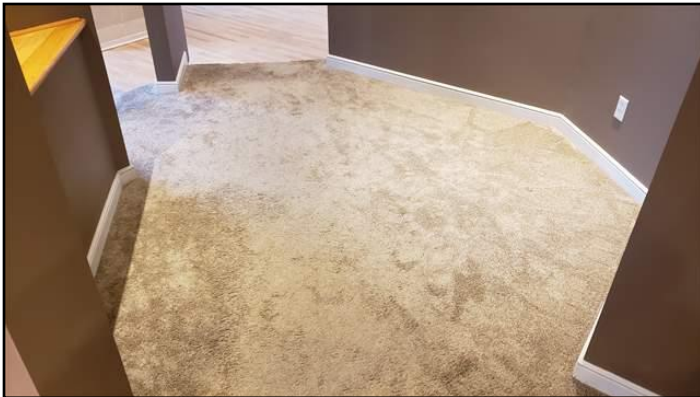
The floors in the hall and kitchen squeak a little bit. After time the floor joist will bend slightly causing the nails to separate from the joist which causes them to move (squeak).

Squeaky Floors

*Recommend repairing the floor joists whenever the flooring is replaced.

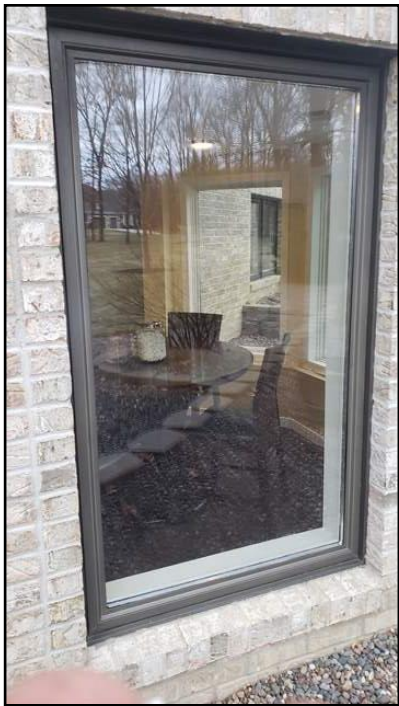
Excess condensation was noted at one of the rec room windows. This is a sign of worn or lost seals. Ultimately the only way to mitigate this issue is to replace the seals and window pane.

Excess Condensation

*Recommend replacing the seals and window panes for the best results.

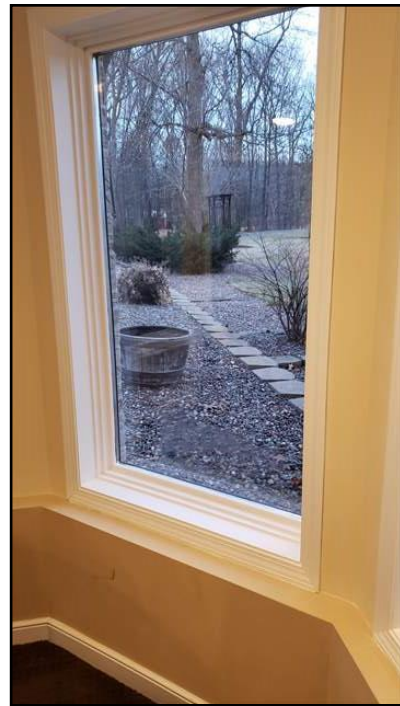
Excess Condensation
